## **BUTTON BIT FAILURES**

#### **BODY WASH**

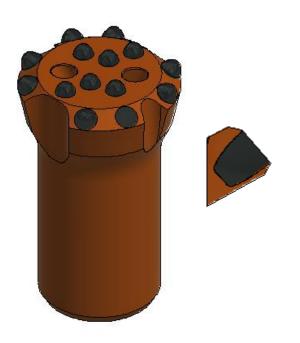
## TOP OF BUTTON SHEAR OFF LEVEL WITH BODY

PROBABLE CAUSE	RECOMMENDED ACTION
OVERDRILLING	INCREASE REGRINDING FREQUENCY
SNAKESKIN	INCREASE REGRINDING FREQUENCY
DRILLING INTO METAL	USE CORRECT DRILLING PRACTICES
EXCESSIVE PROTRUSION	REDUCE REGRINDING INTERVAL

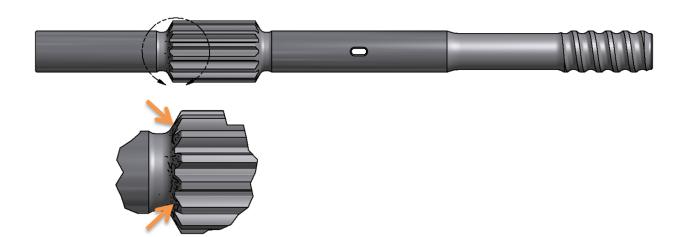
IMPACK MARKS, FRACTURED OR MUSHROOMED STRIKING FACE

DAMAGED PISTON RSPLACE PISTON AND SERVICE

MISALIGNMENT DUE TO WORN OR DAMAGED BUSHING REPLACE BUSHING

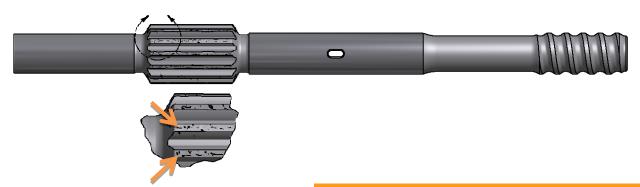
ABNORMAL WEAR ON FORWARD FACE OF SPLINES

PROBABLE CAUSE RECOMMENDED ACTION
WORN HAMER REPLACE BUSHING

STUCK STRING IN BROKEN ROCK

ENSURE PROPER DRILLING
PROCEDURE, USE RETRAC BIT, USE

**ANTI-JAMMING SYSTEM**
